Field Study

UWX550 compressor

March 2011

Cat. No. T1103

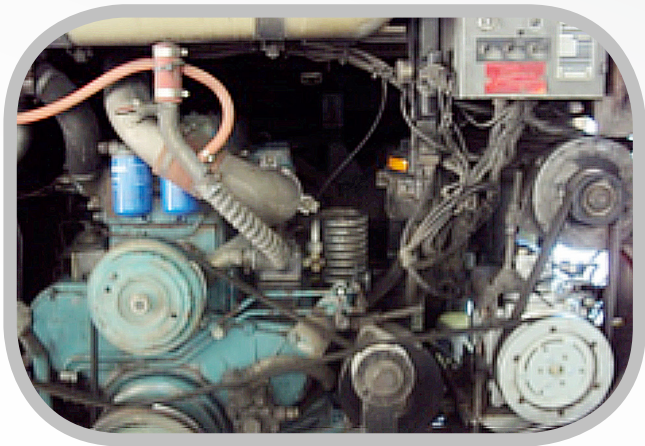
Engine bay.

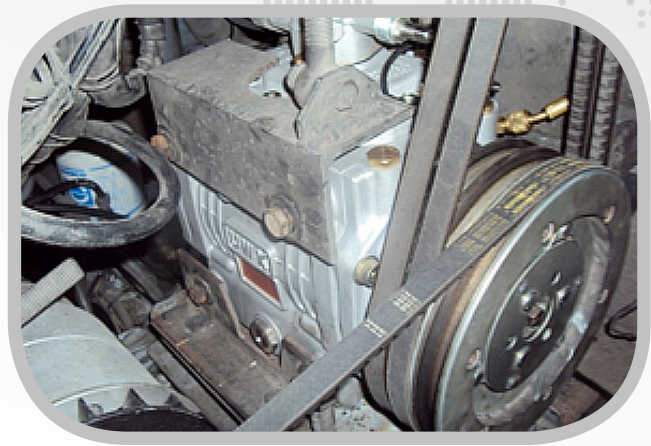
Custom compressor mount bracket and 3B clutch pulley.

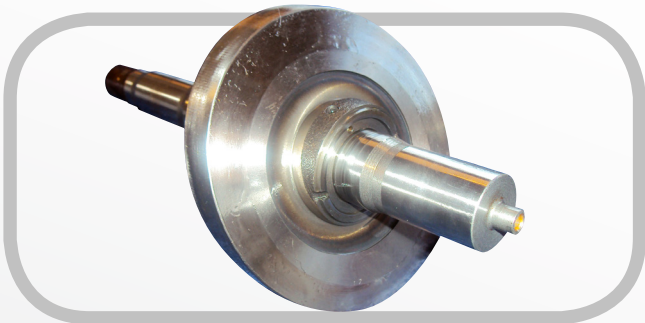
Swashplate

Clearance: 0.05 mm (Standard: 0.020 – 0.022) This enlarged clearance (endplay) was due to normal wear on the contacting surfaces between cylinder and thrust washer. Only some slight scoring was found on the front thrust washers. This would not affect the running operation and durability of the compressor, or create any abnormal vibration or noise.

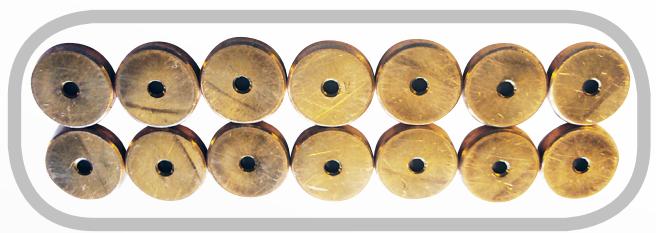
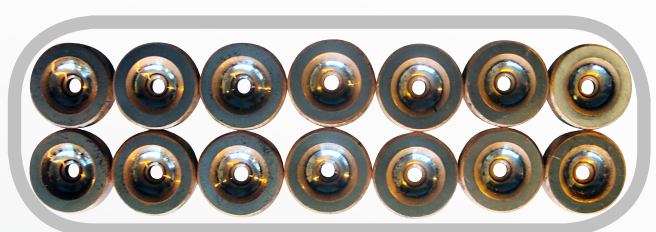
Shoe discs

The sliding sides of the shoe discs were in good condition and within specification for their age. There was no damage to other parts of the discs and they could continue to function normally.

Clearance	1	2	3	4	5	6	7
	0.031	0.030	0.039	0.036	0.033	0.030	0.031

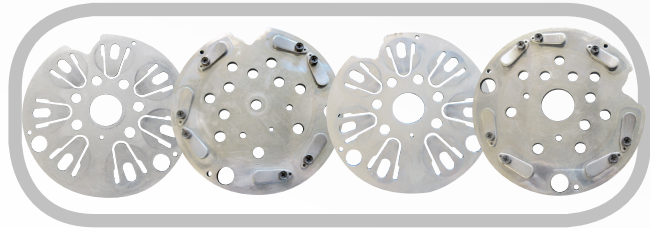
Valve plates

All valve plates were in excellent working order. There was no sign of excessive temperature or pressure during operation, with only some slight scoring on the discharge plate for the oil pump gear.

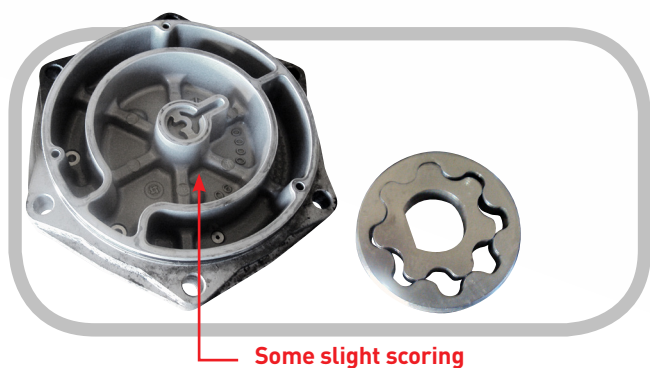
Rear cap and oil pump

Some slight scoring of the oil pump gear housing in the rear cap was found, plus some scoring of the thrust bearing washers. The pump housing was the most likely the source of the small metal particles found in the receiver drier filter, but the thrust bearings and oil pump operation were otherwise still within specification.

The rear cap and oil pump were both in good condition, with the rear cap showing some slight scoring in the oil pump chamber.

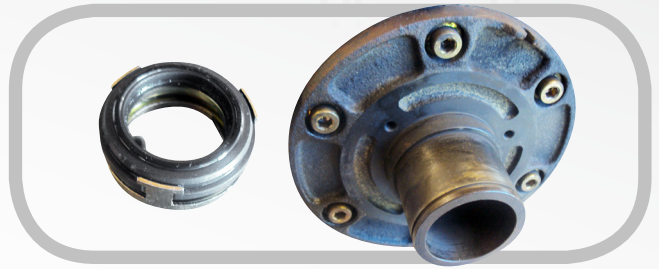
Front nose cone and shaft seal

Both in good condition with no abnormalities.

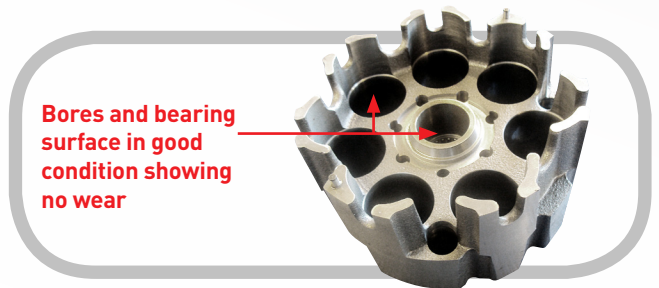
Cylinder housing

Showing no excessive wear on bores and bearing surfaces.

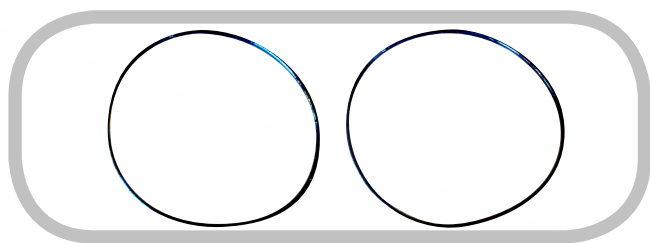
Front and rear cap O-ring

Both in good condition with no abnormalities.

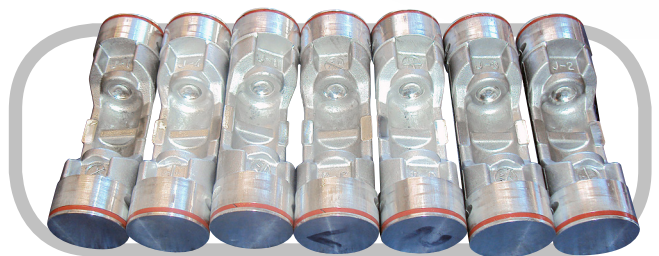
Pistons and ball bearings

All in good condition with no sign of excessive wear or chaffing.

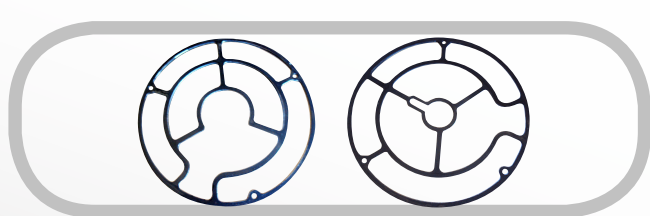
Front and rear gaskets

Both in good condition with no abnormalities.

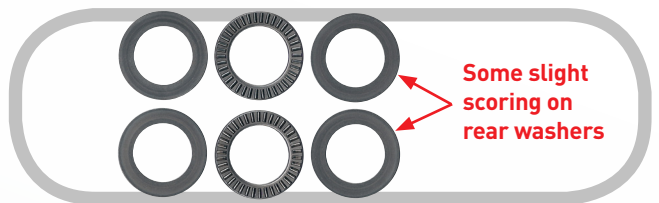
Thrust bearings and spacers

Showing normal wear with some slight scoring in the rear washers.
