UP115 compressor

May 2017

Unicla Cat. No. T1701

The purpose of this test is to examine and analyse a Unicla compressor model UP115 which has been in the field since 1994 and had worked for an estimated 17000 hours.

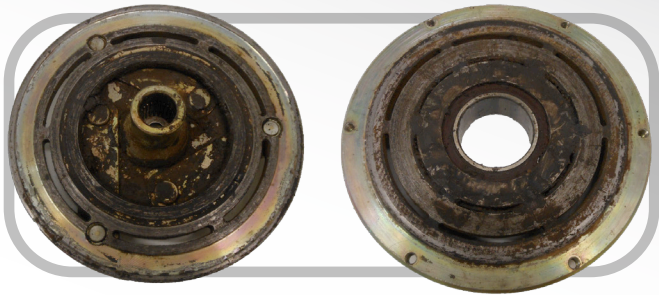
Clutch

It was found that the compressor was not faulty and the issue was related to the clutch system.

The clutch system was fine mechanically, however as it can be seen in images over a long period of time, a lot of mud and grime had worked its way between the armature plate and the pulley surface and had then jammed, effectively gluing the plates together.

The armature was jammed against the pulley by solidified mud and grime

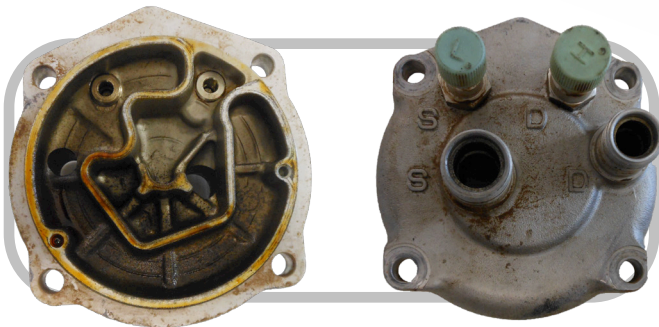
Rear cap

The leak test also indicated that the compressor port or rear cap was not leaking and the actual leak was later found on the hose side of the connection.

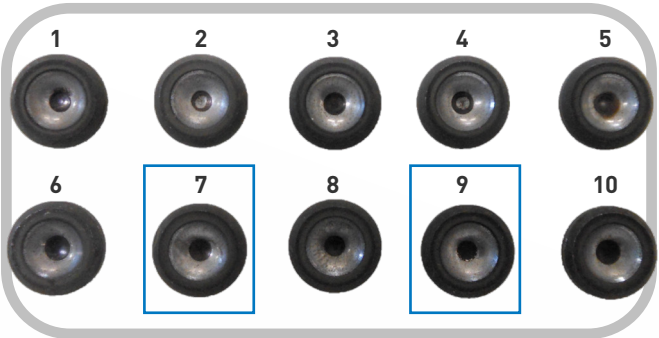
Shoe discs

The thickness of the shoe discs normally are manufactured in the mid-range of 3.55mm. Considering the high working hours and conditions, and the fact the compressor was operating with low levels of gas and oil, caused by the offending gas leak on the suction hose, the wear was acceptable with only 2 of the 10 shoes discs showing out of tolerance wear (marked in red table below).

All shoe discs were slightly worn with number 7 and 9 reaching an out of design tolerance

Shoe disc number	1	2	3	4	5	6	7	8	9	10
Dimension (mm)	3.42	3.55	3.56	3.55	3.53	3.39	3.34	3.39	3.33	3.55
Allowance range	3.35 - 3.75 (3.55 ± 0.2)

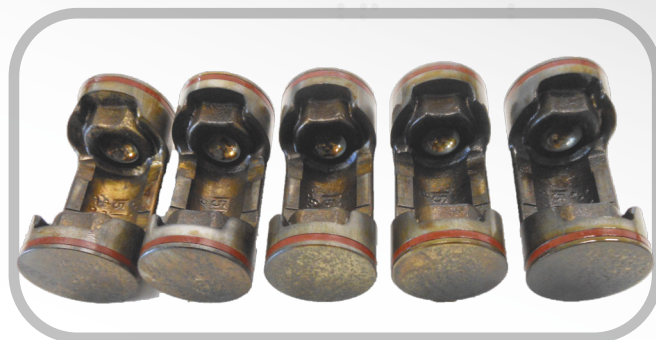
The cylinder housing compression chambers and the pistons were showing average wear of only 0.05mm, which is an excellent result considering the life of compressor. This confirms Unicla's claim that the compressors maintain their compression after very long periods of use.

The piston ring and body measurement results (in millimetres) in table 2 show the minimum wear that has occurred on these parts since the time of manufacture of the compressor. Pistons originally measured 30.52mm and rings 30.47mm.

Pistons from the compressor

Piston number	Front ring D	Rear ring D	Body D
1	30.35	30.37	30.52
2	30.40	30.40	30.52
3	30.37	30.45	30.53
4	30.34	30.42	30.53
5	30.39	30.37	30.52

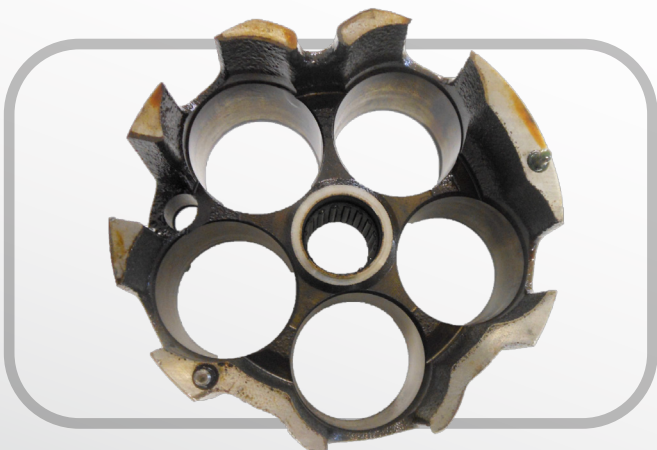
Cylinder housing

All internal components displayed signs of fatigue and overheating, but the compressor was still operational. The extreme overheating was caused by the low refrigerant flow and lack of compressor cooling.

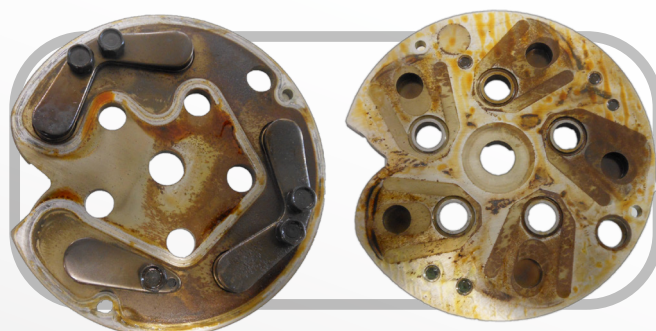
Clear sign of overheating on valve plates
