UPF170 compressor

Cat. No. T1702

Vehicle make and model	Mitsubishi FM 10.0
Body type	Full fibreglass body 5.3 metres in length, polyurethane insulation
Refrigeration system	Transfridge OED-14 with R404a refrigerant - 3kW capacity
Compressor type	Unicla UPF170 with 132mm AA clutch - serial no: 240560

This report reveals the high temperature levels in the system caused from the low refrigerant conditions and how it impacted on the compressor. The main components affected are the shaft seal, rear cap housing and the rear oring. The final leakage at the heat fatigued oring resulted in the replacement of the compressor after six and a half years of service and 355,000km.

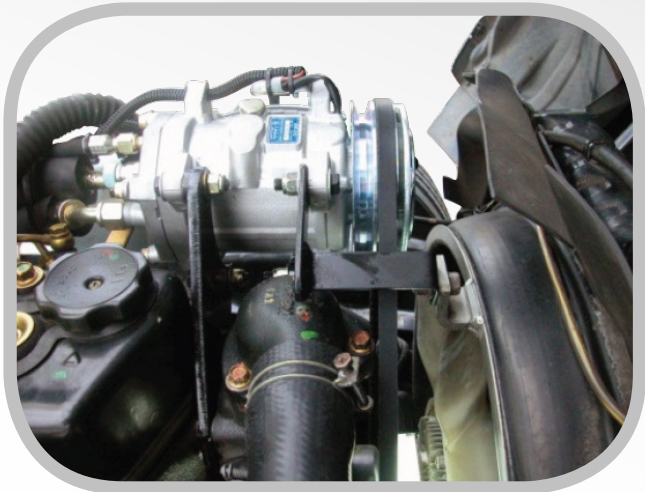
Compressor mounted to engine.

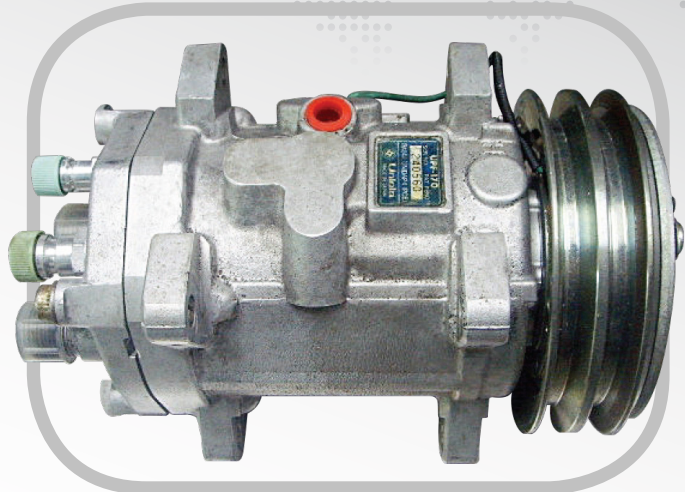
Actual UPF170 compressor.

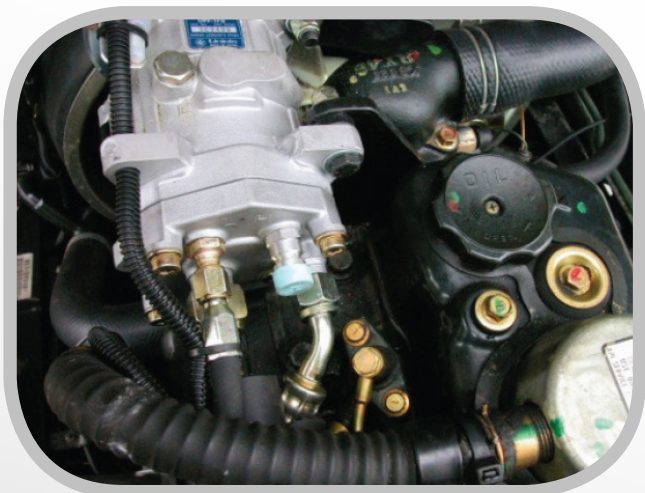
Rear view with horizontal refrigerant hose connections, plus oil return line fitted in place of suction service fitting to rear cap.

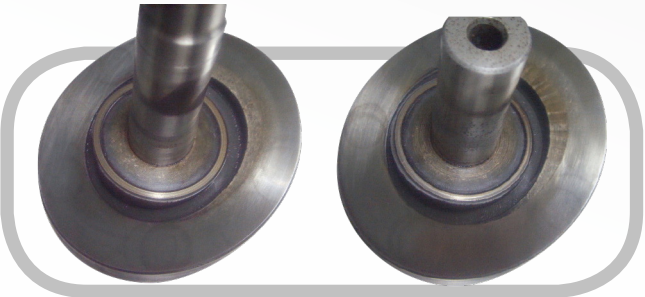
Front and rear surfaces of swashplate

Clearance: 0.150 mm (Standard: 0.020 - 0.022). This enlarged clearance (endplay) is due to normal wear on the contacting surfaces between cylinder and thrust washer. No damage was found on these surfaces or the thrust washers. This would not affect the running operation and durability of the compressor, however may cause a slight noise.

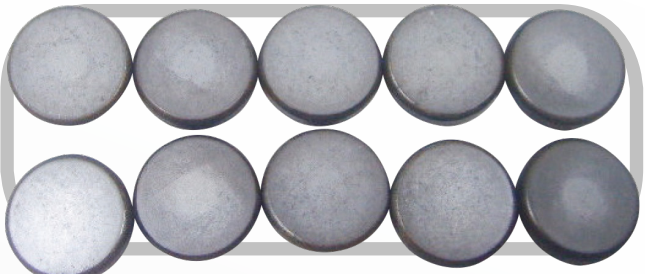
Shoe discs

Clearance: (Standard: 0.020 - 0.022). The sliding sides of the shoe discs are in good condition and within specification for their age. No damage to other parts of the discs and they could continue to function normally.

Clearance	1	2	3	4	5
	0.056	0.050	0.045	0.057	0.057

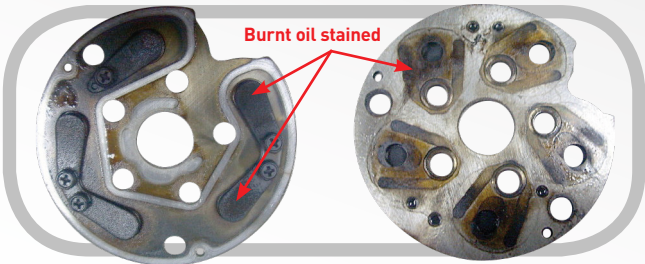
Front discharge valve plate assembly (front & rear)

All valve plates are in normal working order. Burnt oil stains are evident which is most likely caused from excessive temperatures during operation with low gas. Rust is evident on the rear discharge plate, however this has appeared from exposure to air and moisture after removal from the system.

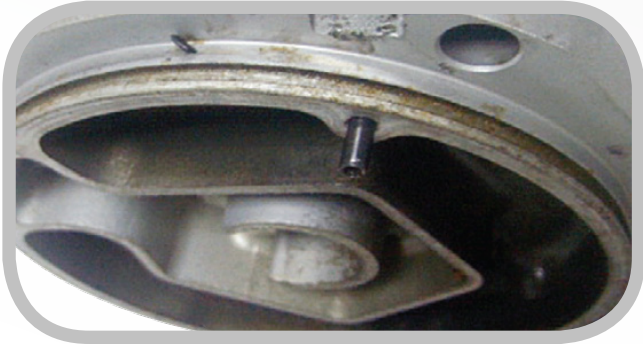
The rear cap is still in good condition, however the inside section had black and burnt oil stain on both high pressure and low pressure chambers. The high temperatures causing this condition have also contributed to the oring stress on rear cap, causing the oring to break its seal (see photos on this page).

Oring groove is dirty

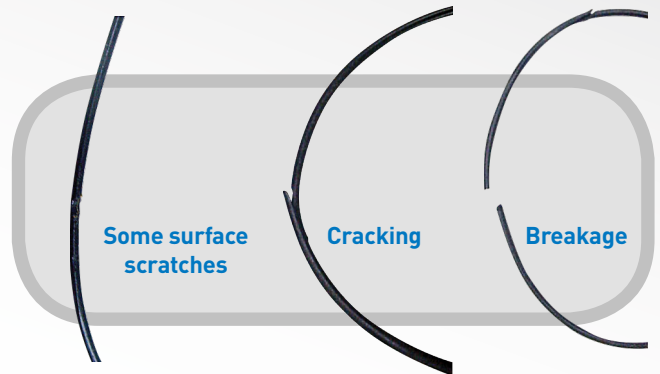
Rear cap oring

Inspection on rear cap oring. The oring groove on the rear cap is dirty with burnt oil and oring deposits turning to carbon from excessive heat. Sections of the oring have hair line cracks caused from the removal and inspection process (oring is slightly brittle).

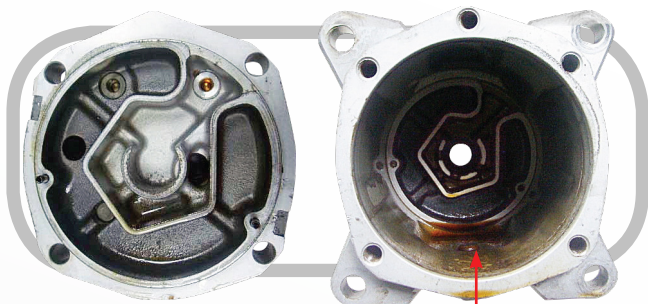
Remaining burnt oil

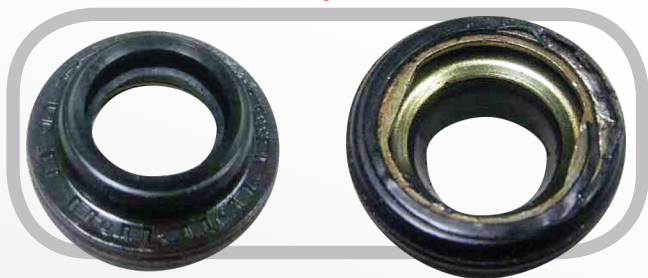
In good condition with no abnormalities. Installed in November 2006.

Shaft seal - no abnormalities

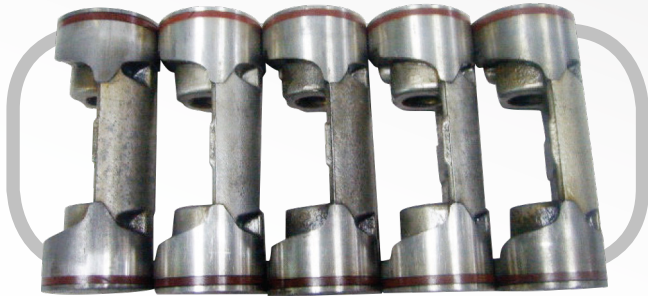
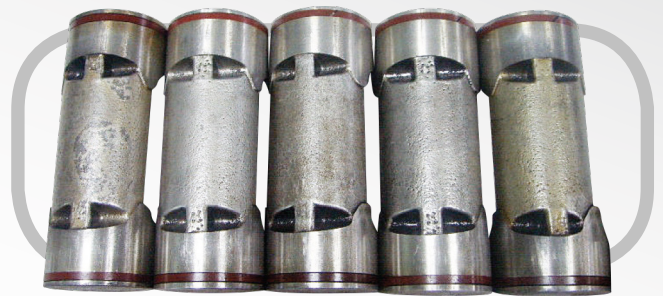
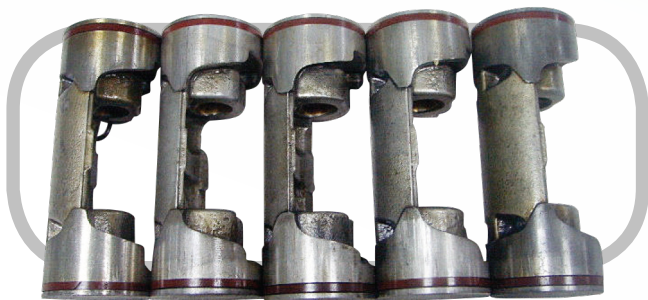
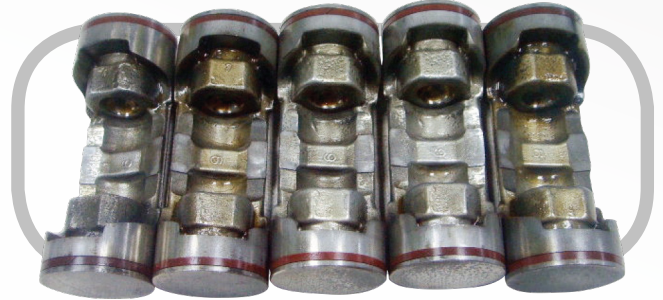
All in good condition, showing slight chaffing.
