Field Study

UWX550 compressor

Surfers Paradise Coaches Australia

Unicla Cat. No. T1802

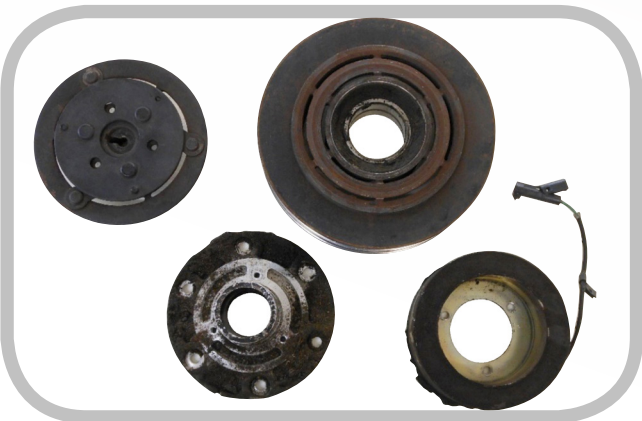
Clutch set

The clutch system was fine mechanically, however, as it can be seen in the images, over a long period of time dirt and grime had worked its way between the armature plate and the pulley surface. The clutch pulley also appeared to have diesel oil soaked over it but the pulley was still smooth and tight, and operating satisfactorily. With new bearings and a clean, the clutch could be returned to service.

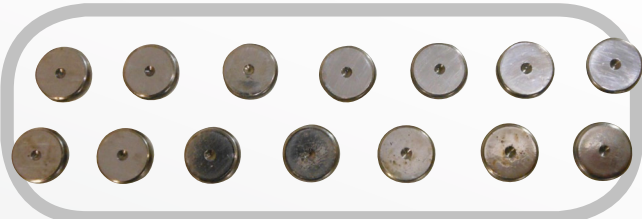
Shoe discs

The sliding sides of the shoe discs were in good condition and within specification for their age. There was no damage to other parts of the discs and they could continue to function normally. The measurements can be found in the below table.

Shoe disc number	1	2	3	4	5	6	7
Height (mm)	8.70	8.70	8.72	8.70	8.69	8.71	8.70
Shoe disc number	8	9	10	11	12	13	14
Height (mm)	8.72	8.71	8.70	8.71	8.70	8.70	8.69

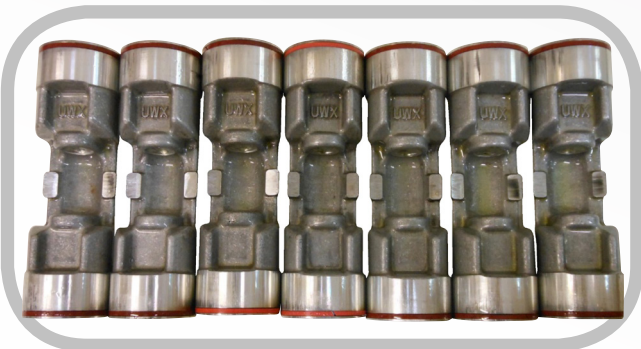
Pistons from the compressor

The cylinder housing compression chambers and the pistons were showing minimum wear, which is an excellent result considering the life of compressor. This would confirm Unicla engineers' claims that the compressors can maintain their compression after very long periods of use.

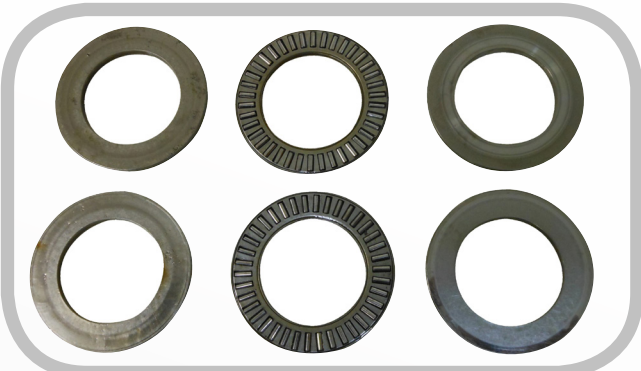
Thrust bearings and spacers

Showing normal wear with some slight scoring in the rear washers.

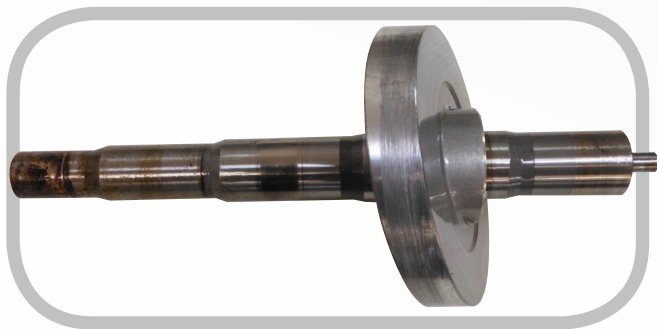
Swashplate

Nothing significant was found. Normal operational wear was visible on the plate and shaft.

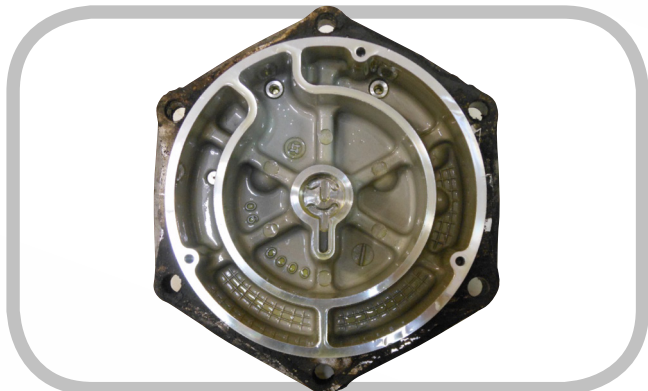
Rear cap

The rear cap and oil pump were both in good condition, with the rear cap showing some slight scoring in the oil pump chamber.

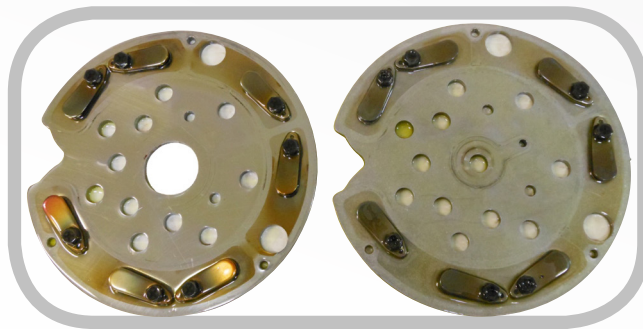
Swashplate

All valve plates were in excellent working order. There were some minor signs of excessive temperature or pressure during operation, with only some slight blackening on the discharge valve plate. This was most likely caused during periods of the system operating low on refrigerant from the leaking discharge line that was replaced twice during the period of service.

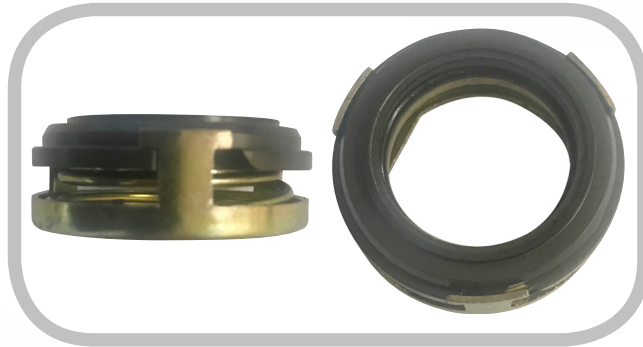
Shaft seal

The front nose cone is in good condition. The shaft seal was the main issue, causing a refrigerant leak. The reason appears to be a small chip/crack in the ceramic ring as shown in the images.

assembly of the compressor – are capable of further operation in the field. The compressor was only in need of a new shaft seal. With this replaced, and the clutch cleaned or replaced, the compressor is now ready to return to service.
