UPF170 compressor

Cat. No. T1702

Vehicle make and model	Mitsubishi FM 10.0
Body type	Full fibreglass body 5.3 metres in length, polyurethane insulation
Refrigeration system	Transfridge OED-14 with R404a refrigerant - 3kW capacity
Compressor type	Unicla UPF170 with 132mm AA clutch - serial no: 240560

This report reveals the high temperature levels in the system caused from the low refrigerant conditions and how it impacted on the compressor. The main components affected are the shaft seal, rear cap housing and the rear oring. The final leakage at the heat fatigued oring resulted in the replacement of the compressor after six and a half years of service and 355,000km.

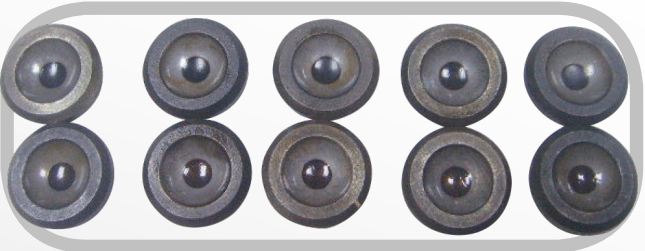
Valve plates

All valve plates are in normal working order. Burnt oil stains are evident which is most likely caused from excessive temperatures during operation with low gas. Rust is evident on the rear discharge plate, however this has appeared from exposure to air and moisture after removal from the system.

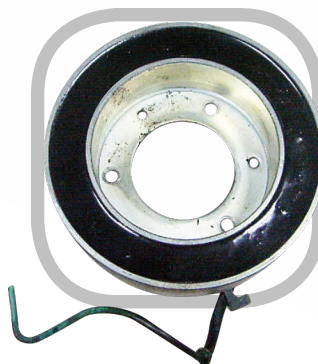
Clutch pulley

Bearing is operational with slight roughness.

Small deformation from impact with another object, possibly during servicing or removal.
